ODI Action Number: **EA00-020**

Subject: **VOLKSWAGEN OF AMERICA  
1996 PASSATS AND JETTAS**

## **ALLEGED LIGHTS AND/OR WINDSHIELD WIPER FAILURE**

SUBJECT: Ignition Switch Failure Resulting in Potential Loss of  
Headlamp and Windshield Wiper Function

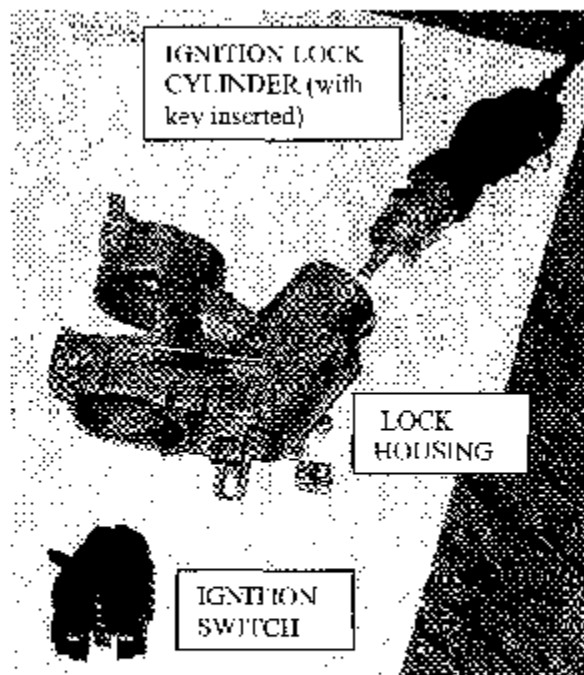
**ALLEGED DEFECT:** The ignition switch may fail to return to the "RUN" position after engine start, resulting in potential loss of the Power Accessory Circuit that includes the headlamps and windshield wipers.

**DESCRIPTION OF COMPONENT/VEHICLE SYSTEM:** The subject components include the ignition switch, the ignition lock cylinder, and the switch cylinder housing (Figure 1).

FIGURE 1. Subject Components.

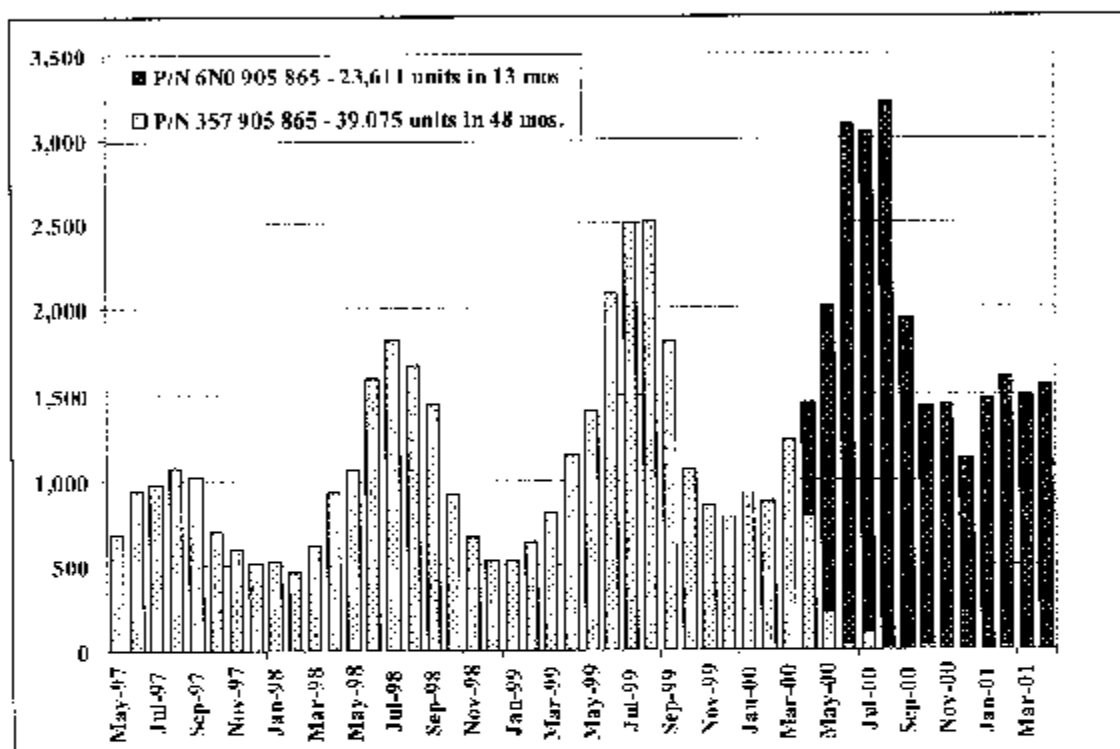
**PART SALES:** Figure 2 shows the trend in sales of the subject ignition switch and its successor in the period from May 1997 through April 2001. The data show high sales volumes with a seasonal pattern that peaks in summer months. VW noted that the subject switches are used as service replacement parts in almost 800 thousand VW vehicles.

FIGURE 2. Ignition Switch Sales Trends by Calendar Month,  
48-Month Period From May-97 to Apr-01.

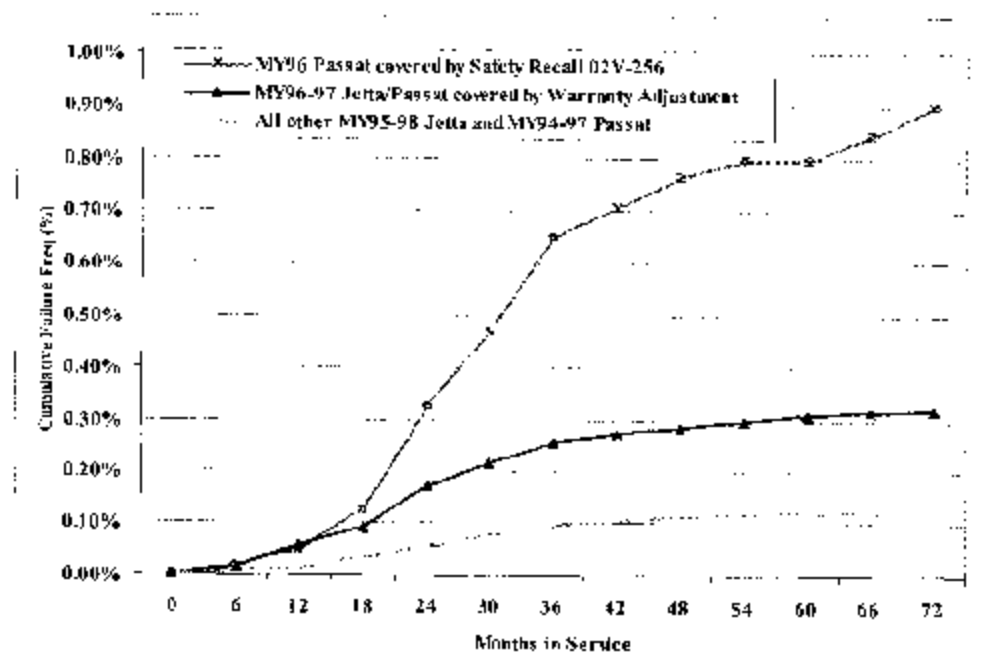
FIGURE 3. Cumulative Failure Frequencies of: (1) Recalled MY96 Passat; (2) MY96-97 Jetta/Passat Receiving Warranty Adjustment; and (3) Remaining MY95-98 Jetta and MY94-97 Passat Vehicles.

1. The reported failure data of the recalled Passat vehicles yields a failure rate that is approximately triple that of the vehicles receiving adjusted warranty coverage from VW and almost an order of magnitude greater than the remaining Jetta and Passat vehicles for which ODI collected data from VW during this investigation (Figure 3). The recalled vehicles also
